CAAP Quarterly Report

Date of Report: <July 10th, 2018>

Project Title: <Mitigating Pipeline Corrosion Using A Smart Thermal Spraying Coating System>

Prepared by: <North Dakota State University>

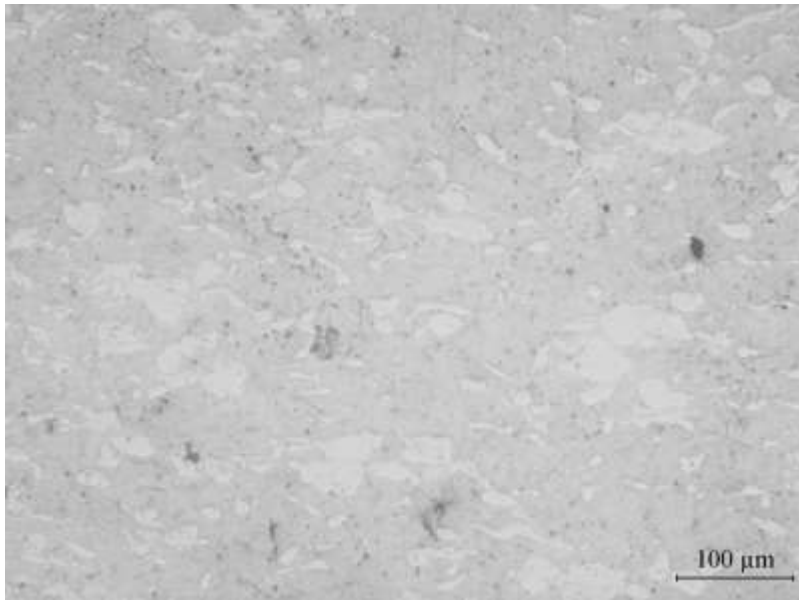
Image Analysis FEA Process Using OOF: After completing the metallography process on the cold sprayed coating samples, several micrographs were taken from randomly selected positions along the cross-section of the cold sprayed coating using optical microscopy. Figure 1 shows an optical micrograph of the as-sprayed coating.

Figure 1. Optical microscopic image of Al-15Zn cold sprayed coating cross-section.

According to Figure 1, there are three different regions on the microstructure of the coating consisting of voids (black), zinc (light gray), and aluminum (dark gray). Therefore, three different groups are created and pixels from each region are added to their corresponding group. As mentioned in the earlier report, pixels are selected based on their contrast using RGB method in Pixel Selection menu. Table 1 shows the number of pixels and percentage of each group.

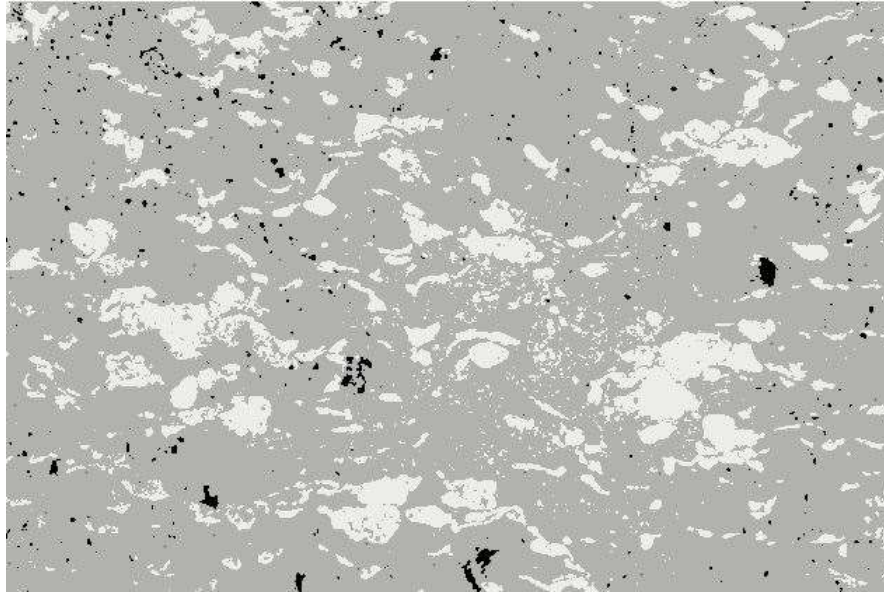
Then, colors are assigned to each group to properly distinguish them from one another. Figure 2 shows the modified image.

Figure 2. Modified image: black, dark, and light pixels representing voids, aluminum, and zinc, respectively.

In the next step, elements are created based on the modified image and produced an elemental structure for numerical simulation consisted of 210 x-elements and 140 y-elements. This

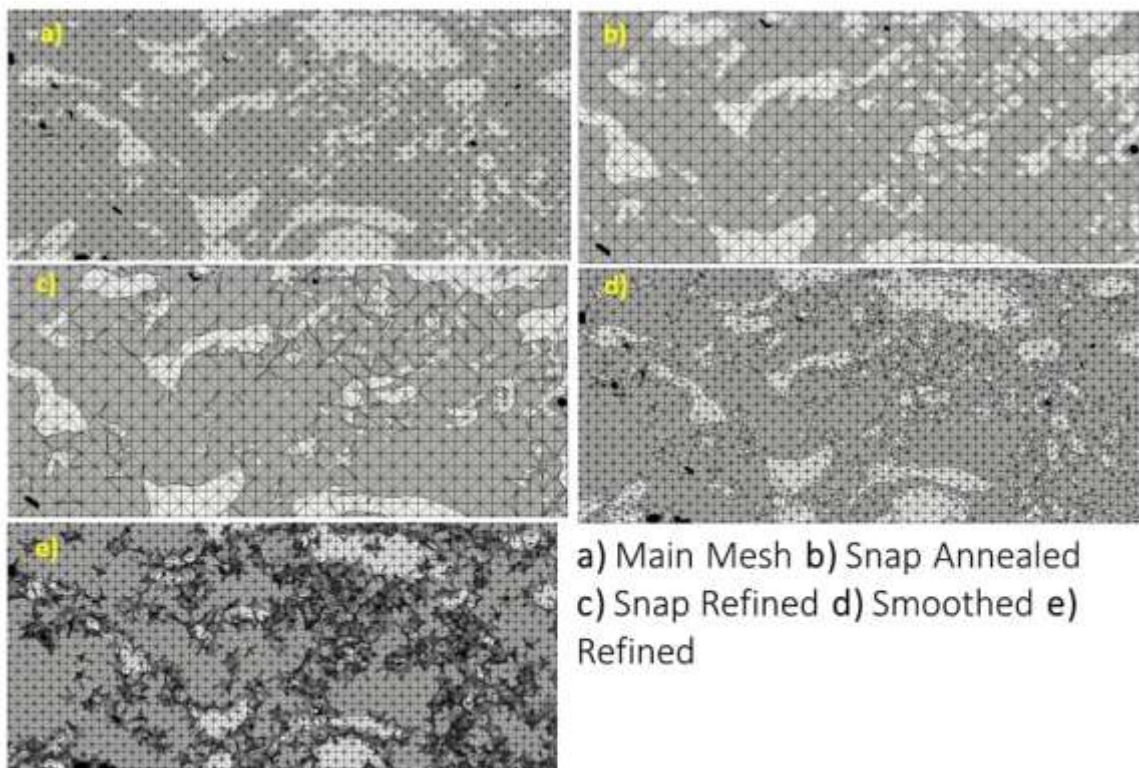
skeleton is further modified to increase the homogeneity of elements. Modification process includes smooth, snap anneal, and snap refine which is shown in Figure 3. The final skeleton reached a homogeneity of 0.982.

Figure 3. Image modification process.

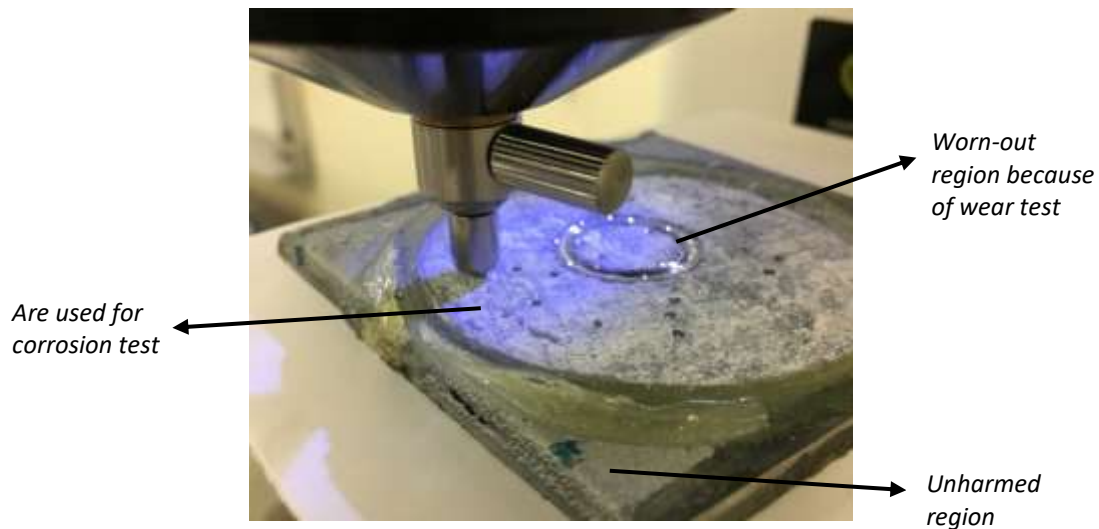
The hardness test was carried out using a Rockwell tester at load of 100 kgf and a steel ball with a diameter of 1.588 mm. Rockwell is a fast method, developed for production control and it has a direct readout. Because of the effects of the corrosion and the wear tests on the coating, there are three regions on the sample, outside of the glued region (R1), inside of the glued region (R2), and the worn-out region (R3) caused by the wear test. The hardness test was performed on each region. Figure 5 shows different regions of sample under hardness test.

Figure 5. Regions used for hardness test.

Number of Test	R1	R2	R3
1	41.8	24.8	42.7
2	47.1	24.6	31.9
3	43.9	35	51.3
4	49.1	38.5	47.7
5	47.3	21.4	38.8
6	51.2	37.2	40.1
7	56.7	38.6	38.7
8	56.3	27.5	39.5
Average	49.17±5.36	30.95±7.09	41.33±5.96

The results of wear test show an improvement of the surface after applying the Al-15Zn wire arc coating as coefficient of friction has dropped and causes less material damage and loss over certain period of time. On the other hand, hardness test results imply that R2 which suffers from salts caused by corrosion test has less hardness than aluminum, while R1 which is as-deposited coating has better hardness behavior compared to bare aluminum. Considering the results of both tests, it can be concluded that applying Al-15Zn wire arc coating improved mechanical properties of the surface.

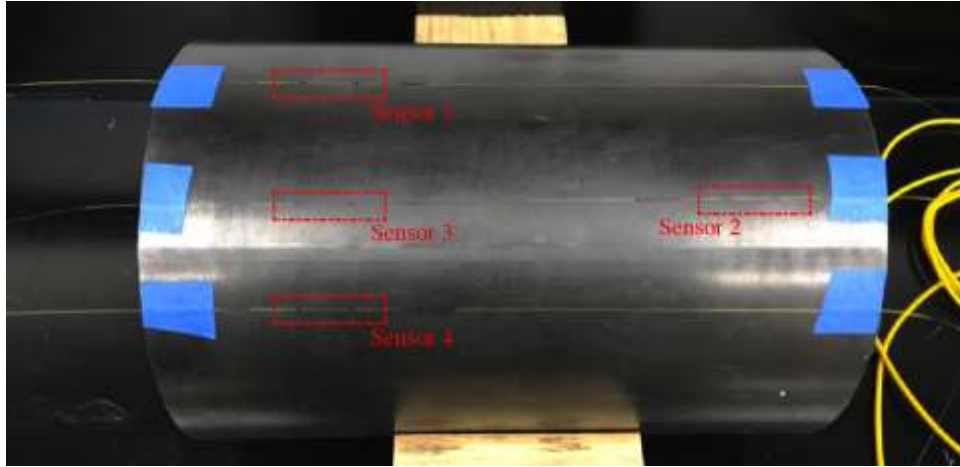
On the other hand, to locate the corrosion on a steel pipe, more than three FBG sensors are estimated to be needed and they should not be on a straight line. Thus, in the full-size pipe teste, a total of four sensors were embedded in the samples with soft coating (tested in this quarter, shown in Figure 6 and samples with hard coating which to be reported in next quarter.

Figure 6. Steel pipe sample embedded with four FBG sensors.

In Figure 6, the blue tapes were only used for fixing the location of FBG sensors, and since they were on the edge of the pipe and not going to react chemically with other material, they would not affect the testing environment.

After applying the soft coating on the surface of the pipe as shown in Figure 6, the pipe was placed in sand with 20% moisture content. The sand fully covered the pipe to simulate the real application environment and the FBG sensors were connected to integrator for data collection as shown in Figure 7 and Figure 8.

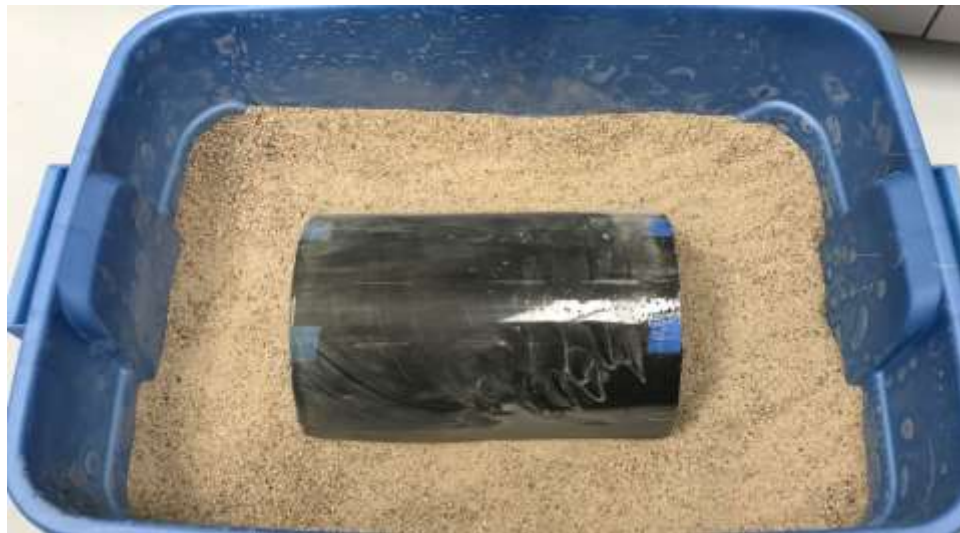
Figure 7. Steel pipe sample coated with soft coating being put in box filled with sand.

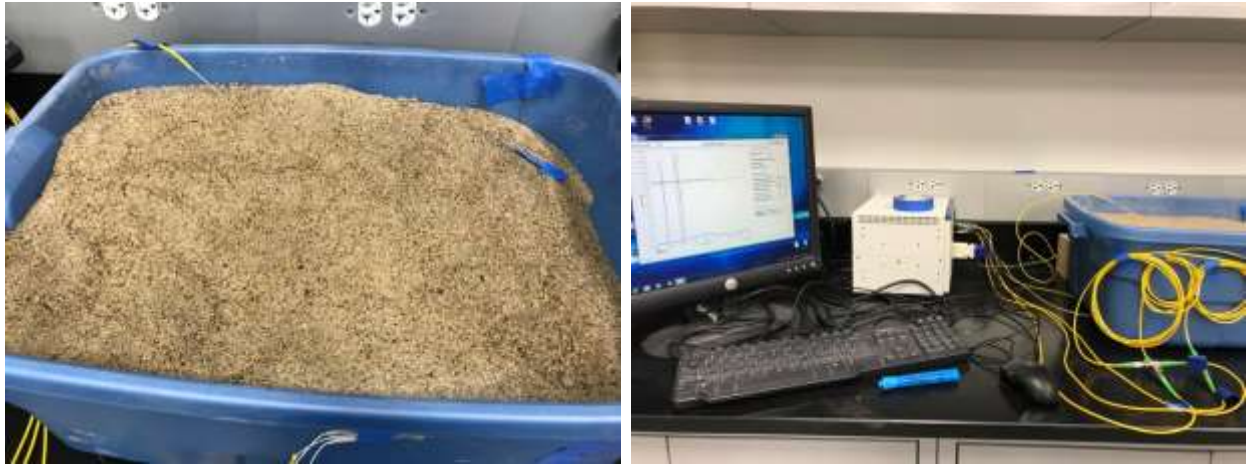
Figure 8. Experiment setup for the steel pipe sample coated with soft coating.

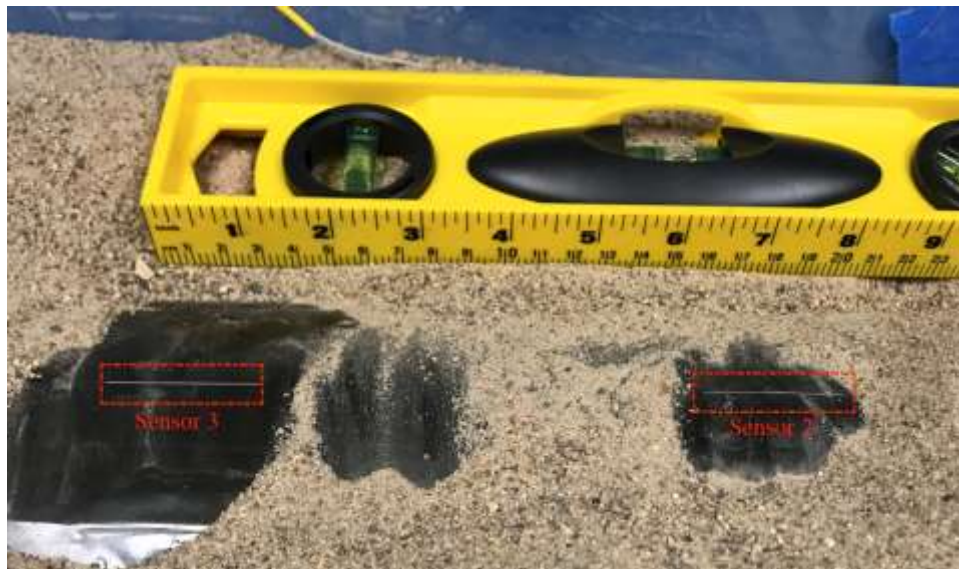
The distances between four embedded sensors were shown in Figures 9 to 11. The distance between Sensor 1 and Sensor 3 is 2 inches, Sensor 2 and Sensor 3 is 7 inches, and Sensor 3 and Sensor 4 is 1.75 inches.

Figure 9. Distance measurement between Sensor 2 and Sensor 3.

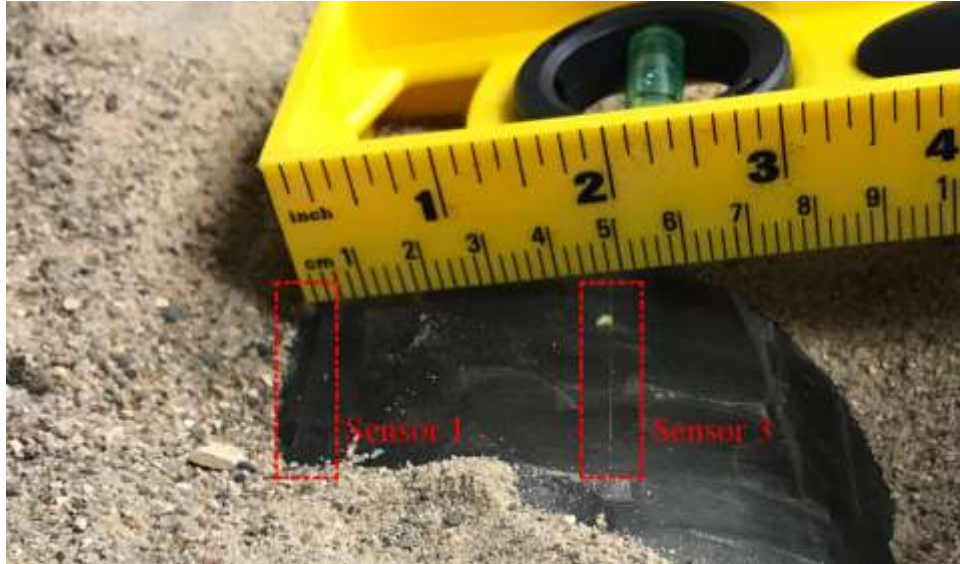
Figure 10. Distance measurement between Sensor 1 and Sensor 3.

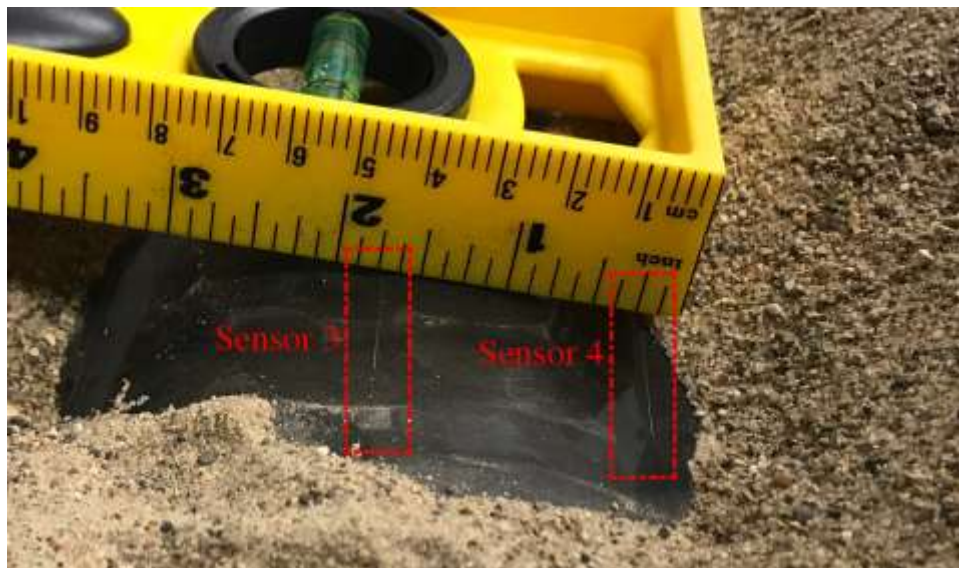
Figure 11. Distance measurement between Sensor 3 and Sensor 4.

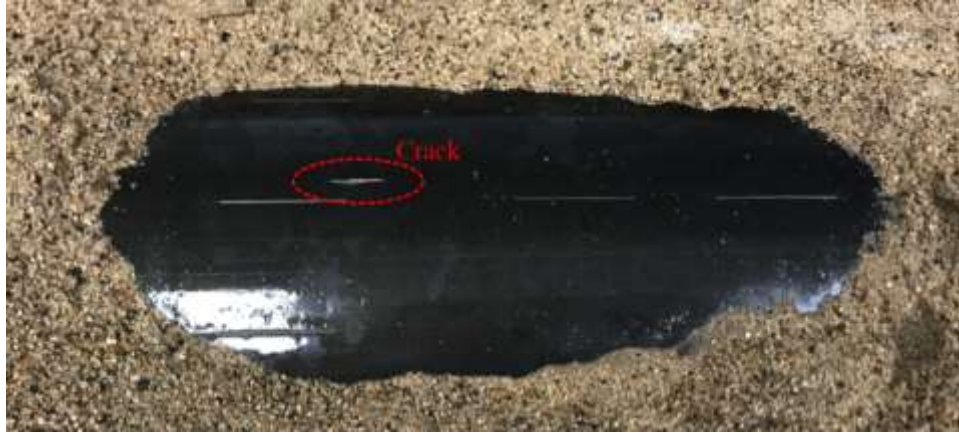
Temperature sensor was located in sand to compensate the temperature effect on FBG sensors. Experiment was started at 2:00pm on May 14th, 2018 and ended at 8:00am on Jun 20th, 2018, which had a total duration of 882 hours. In order to accelerate the corrosion and emulate the coating crack damage, a crack of 0.75 inch in length was made near Sensor 3 around 11:00am on Jun 12th, 2018. The crack location was shown in Figures 12 to 14.

Figure 12. A crack is intentionally made to mock the actual crack happened on coating.

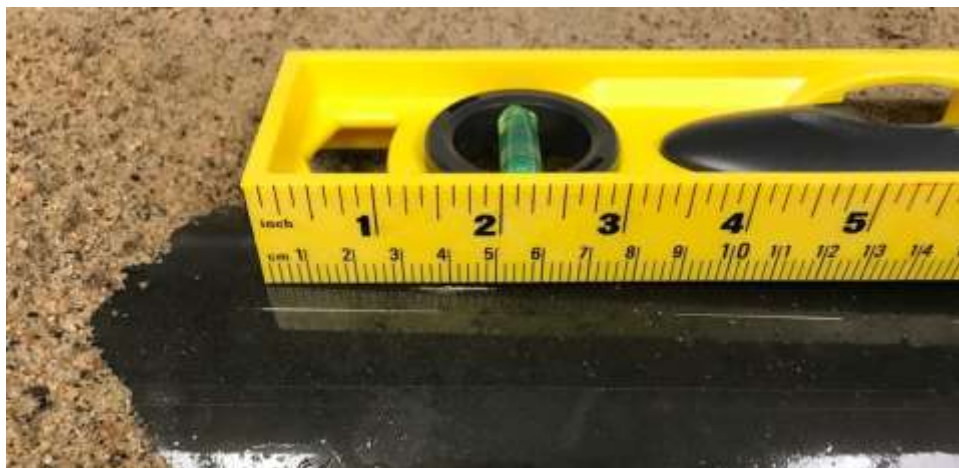
Figure 13. Distance measurement between crack and Sensor 2/Sensor 3.

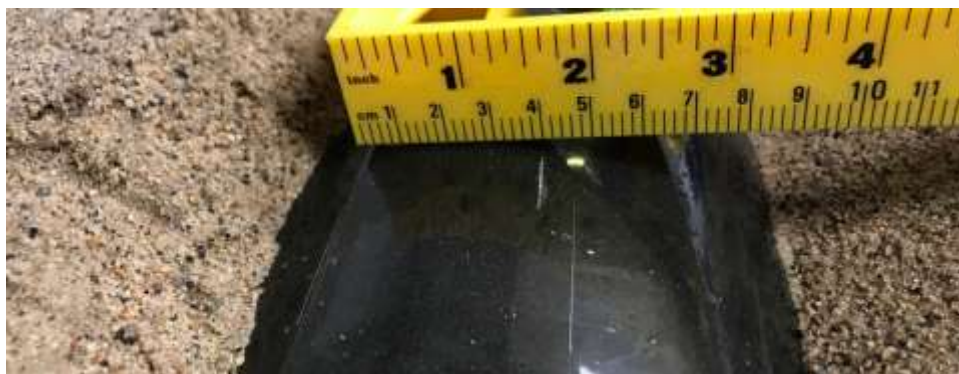
Figure 14. Distance measurement between crack and Sensor 1/Sensor 3.

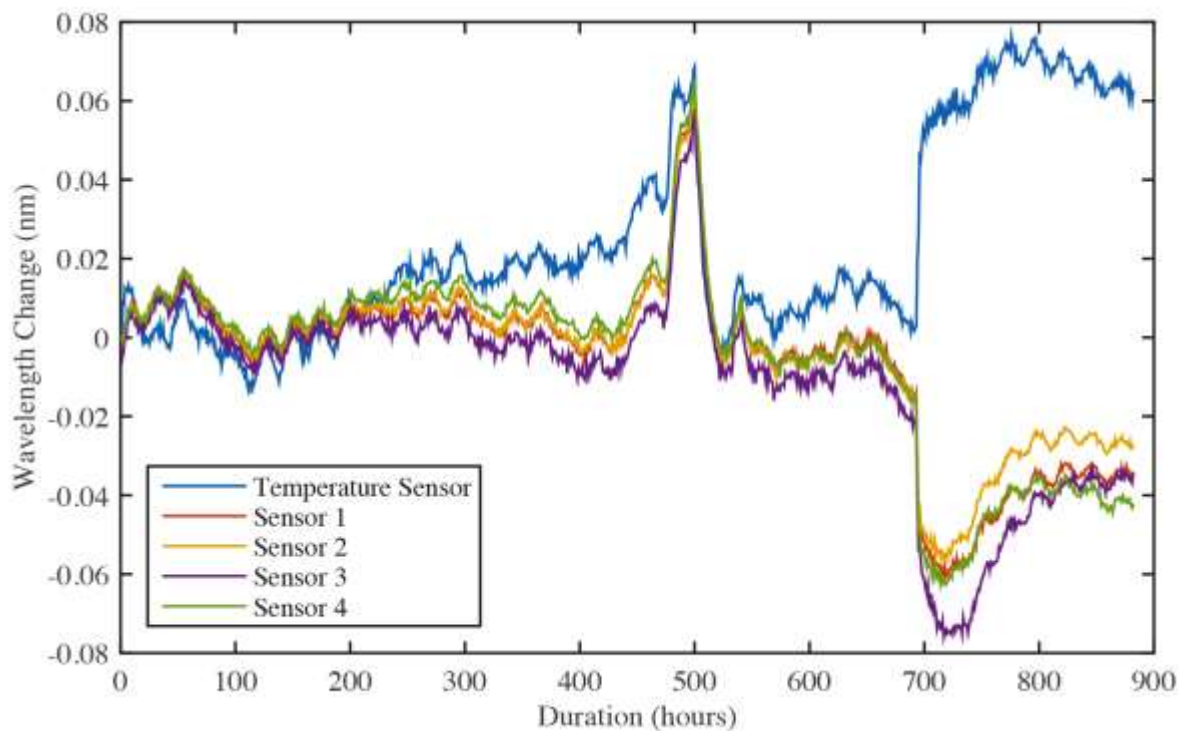
The collected data was shown in Figure 15. After temperature compensation, all data collected by the four FBG sensors were also shown in Figure 16. It can be seen that a dramatic wavelength drop after crack was made on the soft coating, which was expected as our previous results have proven the same effect for multiple times. In addition, after the initial sudden drop the lowest wavelength change value varied from Sensor 1 to Sensor 4. As Sensor 3 had the

Figure 15. Data collected by FBG sensors before eliminating the temperature effect.

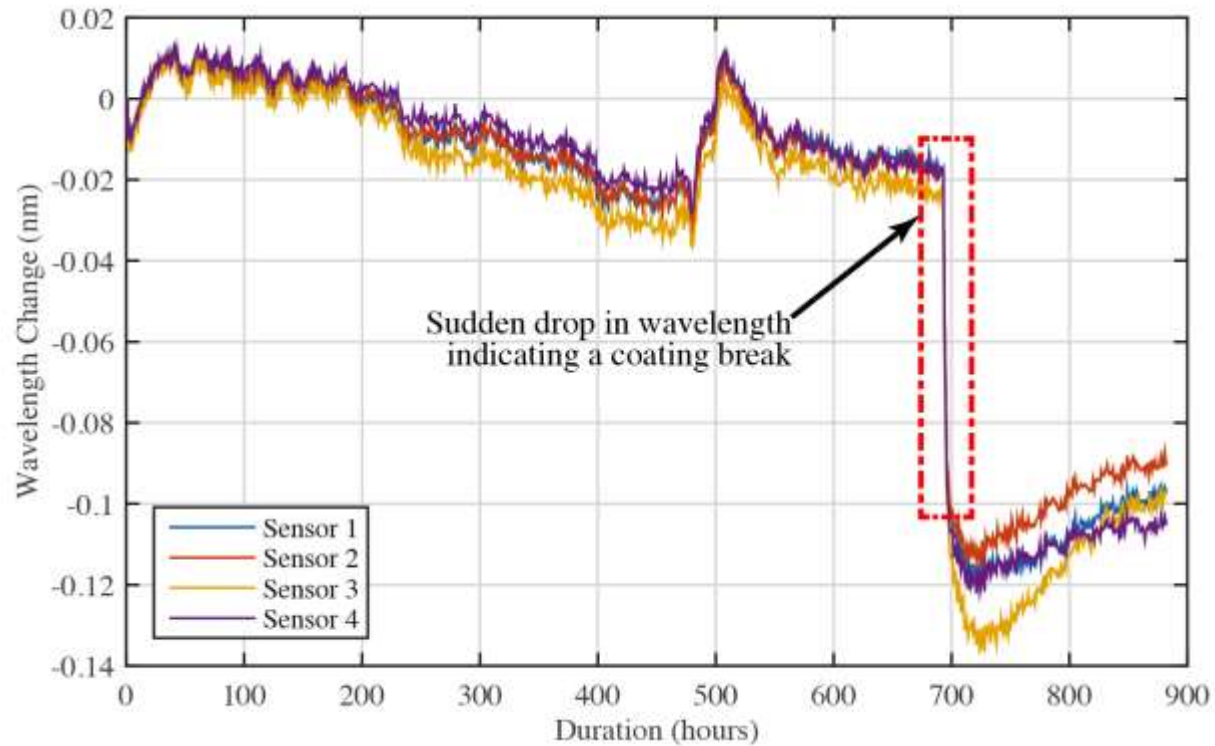
lowest wavelength change value (highest in absolute value), Sensor 1 and Sensor 4 had the second lowest wavelength change value and their value were close to each other, and Sensor 2 had the highest wavelength change value (lowest in absolute value). All these values variations could serve as an indicator to locate the corrosion. By combining the longitudinal and transverse distance from the crack to each sensor, the straight-line distance between the crack and distance could be found, which are 2.03 inches, 6.01 inches, 1.07 inches, and 2.37 inches for Sensor 1 to 4, respectively. The wavelength changes as shown in the graph, could confirm that corrosion was occurred near Sensor 3. The distances from corrosion to Sensor 1 and Sensor 4 are similar to each other and the corrosion is located further from Sensor 2 due to the lowest absolute wavelength change value.

Figure 16. Data collected by FBG sensors after eliminating temperature effect.
